**Richfield Historic District**

**Design Guidelines**

**August 2014 (rev. Nov 2014)**

**Prepared by Bob Parry**

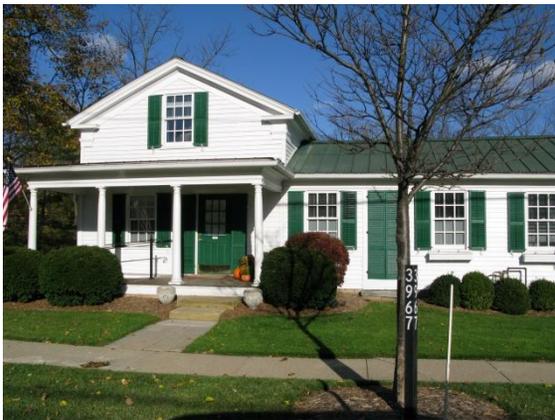
Richfield examples of Greek Revival Plan often referred to as “Western Reserve Style”

Zimmerman, “In many of the structures erected across northeastern Ohio that transplanted New England character manifest itself as a stylistic amalgam of Classical [Greek Revival], Federal, Georgian, Queen Anne, Victorian and Farmhouse Colonial elements that has since been described as Western Reserve Architecture”. A primary book on architecture in northeast Ohio is “Architecture of the Western Reserve, 1800-1900” by Richard Campen, documents numerous original structures and architectural forms found in the Western Reserve in its first century of development. He provides an example of what is commonly identified as Western Reserve style in the Barnes-Goddard house (c.1832) located in Unionville, Lorain County. This small two-story Greek Revival home has a one story addition and “a separate entry through a side wing fronted by a porch”. “This plan, along with other features - corner posts or pilasters, broad frieze boards with low upper windows.. and large box cornices - are supposedly the constituents of a “*Western Reserve Style*”.” The referenced house is similar to a couple house examples found in Richfield specifically at 3967 Broadview Road and 4076 Broadview Road.
